# Misinterpretation of a skin fold artifact as pneumothorax on the chest x-ray of a trauma patient in Korea: a case report

**Case Report**

J Trauma Inj 2024;37(1):86-88 https://doi.org/10.20408/jti.2023.0050

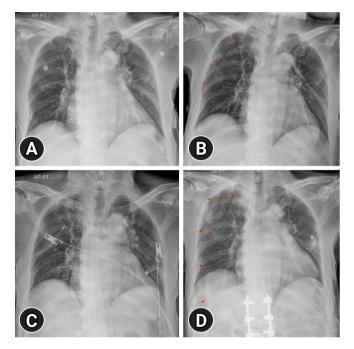
**Fig. 2.** Chest x-ray (CXR) images after hospitalization. (A) After 6 days of hospitalization, CXR shows removal of the right chest tube. (B) After 8 days of hospitalization, CXR shows the right-side skin fold (arrows), which was misdiagnosed as new pneumothorax. (C) To treat the apparent pneumothorax, a chest tube was immediately reinserted at the bedside. (D) The subsequent follow-up CXR after 10 days of hospitalization reveals multiple curvilinear lines (arrows) extending to the upper abdomen on the right, representing skin folds.

initial chest computed tomography and CXR (Fig. 1) showed bilateral hemothorax, so chest tubes were inserted (not shown here). After 6 days of hospitalization, the right chest tube was removed due to decreased hemothorax (Fig. 2A). However, after 8 days of hospitalization, acute pneumothorax was suspected (Fig. 2B) on the follow-up CXR, prompting bedside chest tube reinsertion (Fig. 2C). As there was no evidence of air drainage from the chest tube and a repeat CXR the next day showed no pneumothorax, interdepartment consultation was requested with radiology. The thoracic radiologists confirmed that it was a skin fold and not an actual pneumothorax, leading to removal of the chest tube. The follow-up CXR (Fig. 2D) again showed multiple skin folds from a different view.

- 1. Location: Pneumothorax typically appears along the lung periphery, whereas a skin fold commonly appears to continue beyond the chest wall.
- 2. Shape and sharpness: The linear shadow of pneumothorax tends to be thin, sharp, and well-defined. A skin fold usually appears wider and ill-defined towards the medial side, while appearing sharp towards the lateral side.
- 3. Vascular markings: The distal portion of the linear shadow of pneumothorax often lacks visible pulmonary vessels,
